All Souls' (Hook Memorial) Church, Leeds

THE ORGAN

A REPORT BY PAUL HALE

August 2010

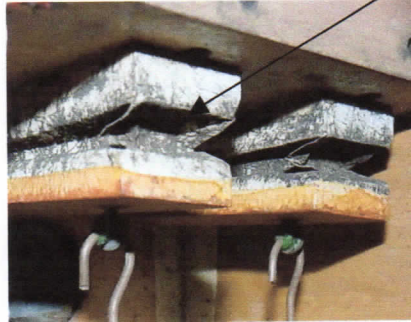
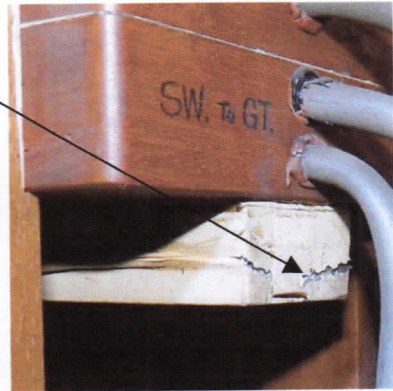
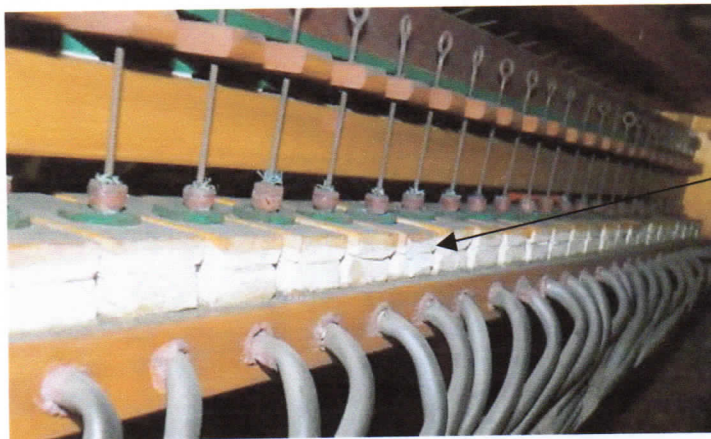
The leatherwork on the smaller moving parts – the pneumatic ‘motors’ – is quite another matter as some is extremely thin and does a great deal of work. Much of it is beginning to fail.

The Great and Swell actions had their leatherwork renewed in the 1990s, if the Jackson quote on file was fully carried out. This needs checking by the quoting organ-builders.

This means that the Choir actions and all the Pedal chests – internal and external motors – all still need releathering.

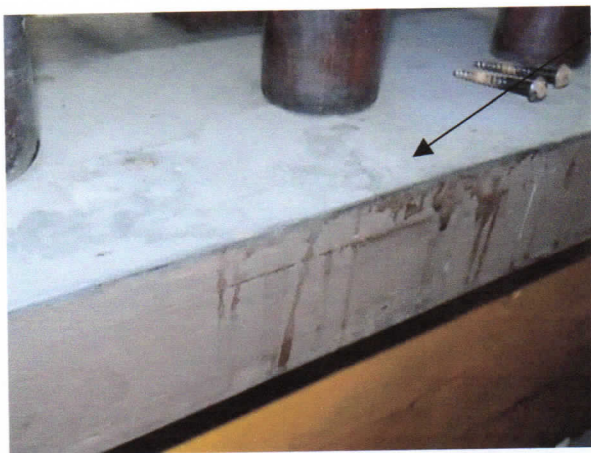
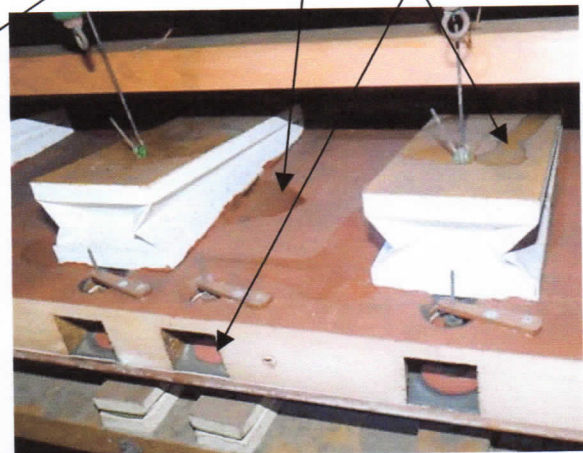
In addition, water has entered the chamber at the East end, run down the 32ft stopped pipes and entered their soundboard. This has seized some of the internal valves and

stuck the pallet-leather of some pallets to the underside of the top board. All this needs restoring as there will be many notes off until it has been. The roof above the East end of the organ chamber needs checking for soundness, unless this has been done already.

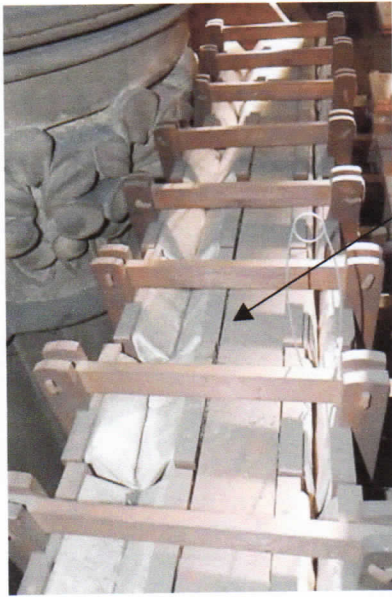
In addition there is a relay under the Swell soundboard which divides the action into two; this also needs releathering, as do any other small relays such as that for the 'stood-off' bass octaves of the Great Diapasons.

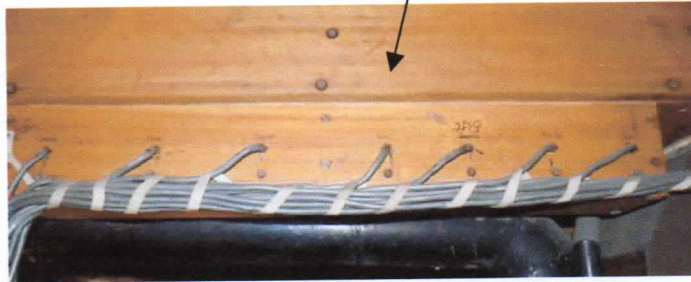
The stop actions need releathering, too – that for the Great being a double-acting machine operating the sliders, those for the Swell and the Choir being ventilators allowing wind into each rank of pipes when a stop is drawn,

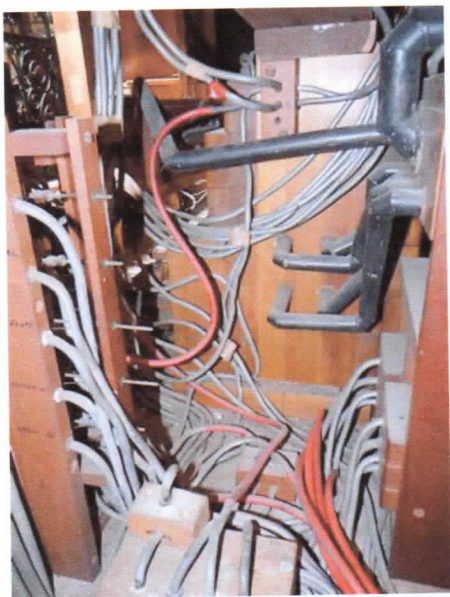
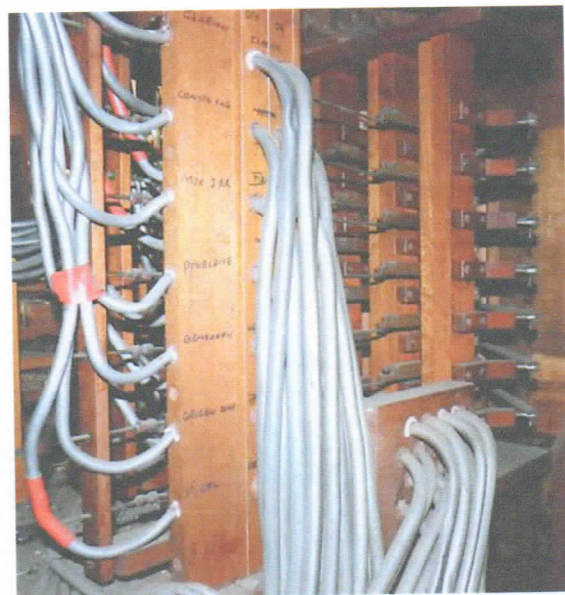
The major task, however, is not this work, much of which can be done piecemeal: it is to address the complex pneumatic machinery behind the console. This mass of tubing, wooden boxes and pneumatic motors has five interlinked functions: (1) to route the pneumatic tubes from each keyboard to their respective soundboards and chests, (2) to enable coupling between manuals and at the octave within / between manuals to take place, (3) to allow certain Pedal ranks to operate at more than one pitch, (4) to operate the organ's stop action within the instrument, and (5) to control the stop-knobs by the pistons between the keyboards and above the pedals. Some of this work is undertaken by pneumatic motors of small and large size; some is undertaken by extremely thin membranes (in the main coupler machine) and some by more sturdy leather pans (operating the stopknobs pneumatically). As far as I can see, no restoration work has been undertaken on all this mechanism, though the sagging and patched-up tube-runs suggest piecemeal attention from time to time.

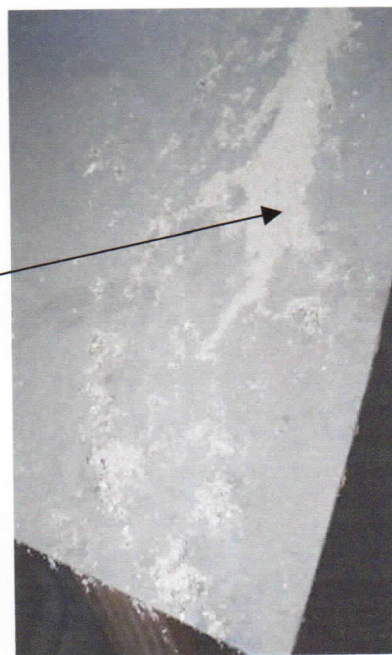
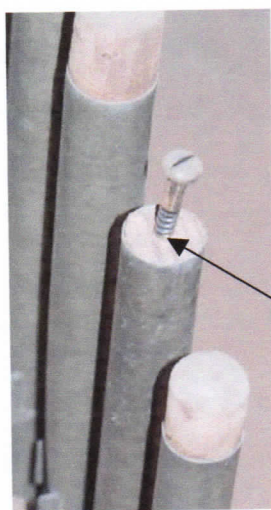
The pipework varies in the amount of dust and dirt sitting in it and around it. That in the Choir box remains pretty clean; the Swell is a little dustier than the Choir (it has two sets of shutters and so admits more dust) and the Great is quite grubby. The Pedal is the dirtiest, because of what falls on it from the walls and ceiling.

The Great/Choir Tromba rank is kept clean only by the sloping board above it, on which fall quantities of grit and dust from the intersection of the chamber roof with the top of the wall above the arch at the head of the north nave aisle.

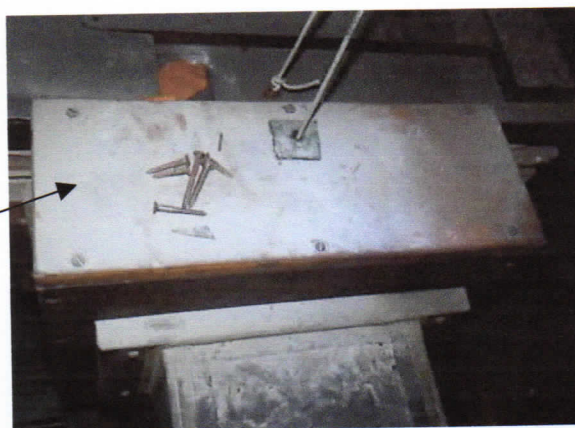
The general areas of the organ are rather dirty, the underneath of the Swell suffering from fine powdery dust drawn in to the actions from a section of lead pneumatic tubes (which appear to be oxidising away to nothing) and expelled out onto the bellows and trunking beneath.

The rogue tubes appear to have been replaced by Mr Carter; further checks are needed to ensure that all such tubing has been identified. It is a highly unusual failing caused by faulty lead casting and can be eliminated from the organ with care and diligence, once some dismantling has taken place.

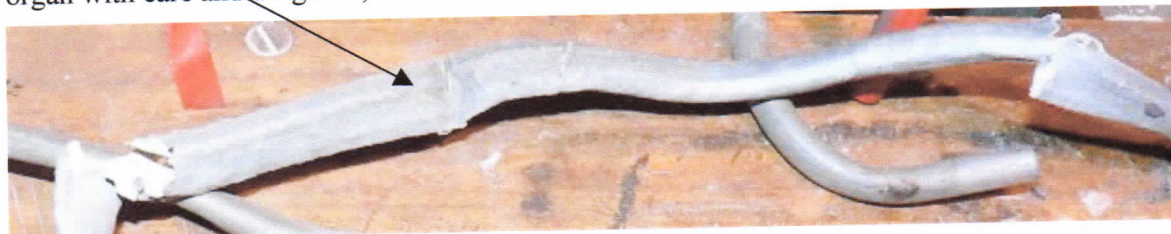
Where tubing has sagged or become untidy (anywhere in the organ) it needs replacing or re-running and re-staying.

It is collapsing, for instance, where it hangs off unit chests, weakened by the bleed-holes pierced by organ-builders to improve note repetition.

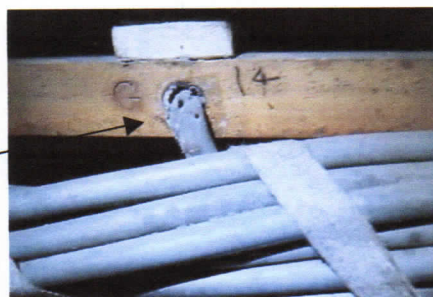
The soundboards are of three types, as has been mentioned: (1) slider soundboard (Great), (2) some sort of cone or pouch valve chests (Swell and Choir) and (3) unit chests (Pedal, Tromba and some off-note chests). The timber portions of the chests are in pretty fair condition; I heard just one 'running' between notes. Other than checking for splits, the Swell, Choir and unit chests need very little work other than the action releathering already mentioned; the Great will need attention to its upperboards, sliders and table to ensure that any splits are sealed and that all is flat and wind-tight.

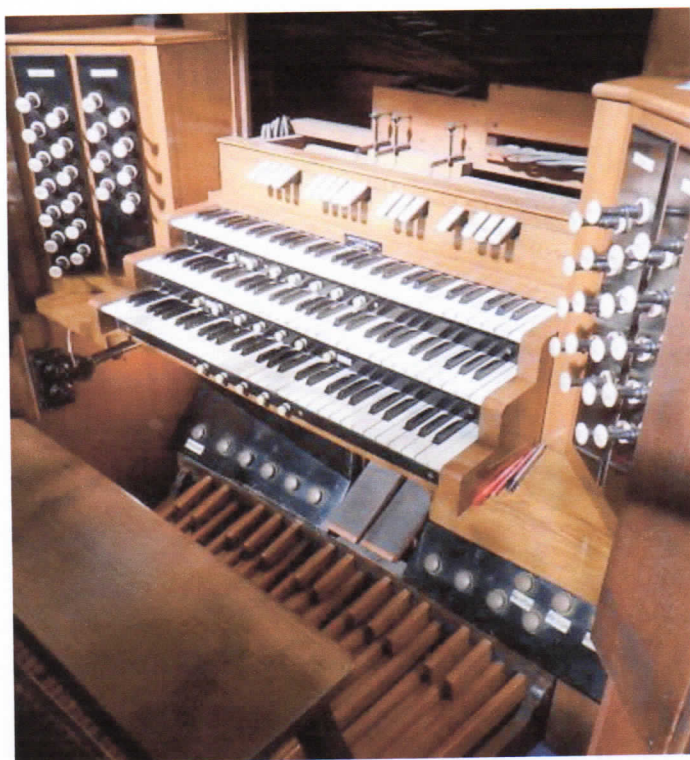
The console is looking smart and well-polished – would that all consoles were so well-tended by their organists. Keys, pedals, pistons, swell-pedals, knobs and wooden surfaces are all lightly worn and would respond well to modest restoration, of which the keys and pistons probably need the most.
