All Souls' (Hook Memorial) Church, Leeds

THE ORGAN

A REPORT BY PAUL HALE

August 2010

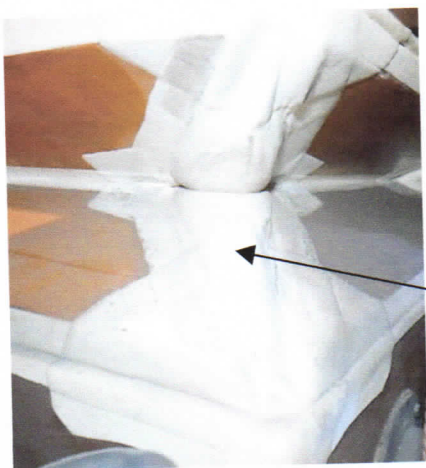
The reservoirs in the organ all date from 1938; I surmise that previously there would have been one large reservoir with perhaps one or two smaller ones. The 1938 rebuild installed a new system (a better one) of individual smaller reservoirs for each soundboard and wind pressure. The leather on all of these appears to be pliant and sound: they do not need releathering and will last for many years.
